Influence of Incident Energy on Sisal/Epoxy Composite Subjected to Low Velocity Impact and Damage Characterization Using Ultrasonic C-Scan

Impact resistance is an inevitable characteristic of the composites employed in the high performance structural applications. Due to the growing interest in the use of sisal fibre as reinforcement in the polymer composites, it is required to determine the response of sisal/epoxy composites to low velocity impact at high incident energies where perforation can occur and assess the damage characteristics using a non-destructive technique. In this work, sisal/epoxy composites were subjected to drop weight impact in the velocity range of 3 m/s to 5 m/s at different energy levels between 20 J to 50 J according to the ASTM D7136. Based on the results observed, it is concluded that both the peak load and absorbed energy increased with the increasing incident energy level up to 40 J. At 50 J, perforation occurred and the maximum deformation was approximately 22 mm for the sisal/epoxy composite. Damage characteristics and failure behaviour of the composite at different incident energies was examined from the visual images of the front and back face of t

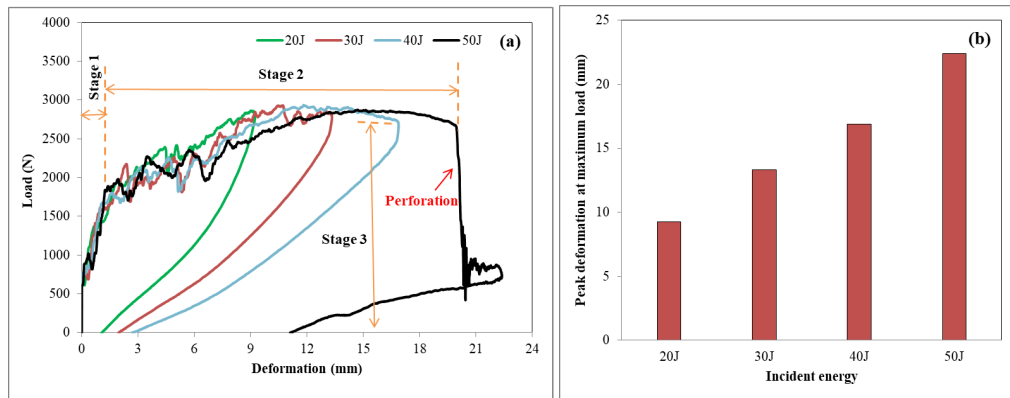
Figure 5: Sisal/epoxy composite at different incident energies (a) Load vs Deformation and (b) Peak velocity attained.

Load-deformation plot from the drop weight impact test is shown in Figure 5(a) and (b). It is evident that impact failure due to impactor mass occurred in 3 stages: Stage 1 is the damage initiation zone, stage 2 is the damage propagation zone and stage 3 is the force unloading part in case of the non-perforation or decline in the load without strain recovery due to the perforation [19], [20].

force unloading part which forms a closed loop implies recovery of elastic energy that helps the impactor to rebound without perforation [21]. At 50 J energy level; the impactor was found to completely penetrate the composite specimen and the maximum deformation was approximately 22 mm as shown in Figure 5(b). The damage due to complete penetration at 50 J is visible from the front and back face of the impacted area as shown in Figure 6(g) and (h).

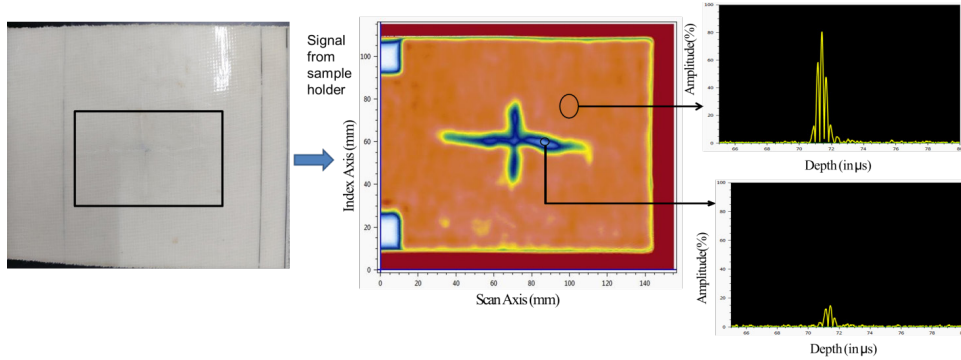
Figure 8: Defect characterization (a) Defective area, (b) Ultrasonic C-scan image and (c) A-scan signal from the unimpacted and impacted area.

Figure 8 shows the ultrasonic C-scan image and Amplitude vs Depth plot from the ultrasonic A-scan. The flaws or discontinuity or damages in a composite material can be assessed from the strength of the amplitude signal. In a typical A-scan image the defect echo from the damaged region has lower amplitude than the area that remains intact [23]. The amplitude signal obtained in the damaged area is weaker than the amplitude signal obtained from the area without damage.
